APPLICATION OF RISK INDEXING TOOL FOR EVALUATION OF CONSTRUCTED DAM SAFETY IN JAVA

CARLINA SOETJIONO

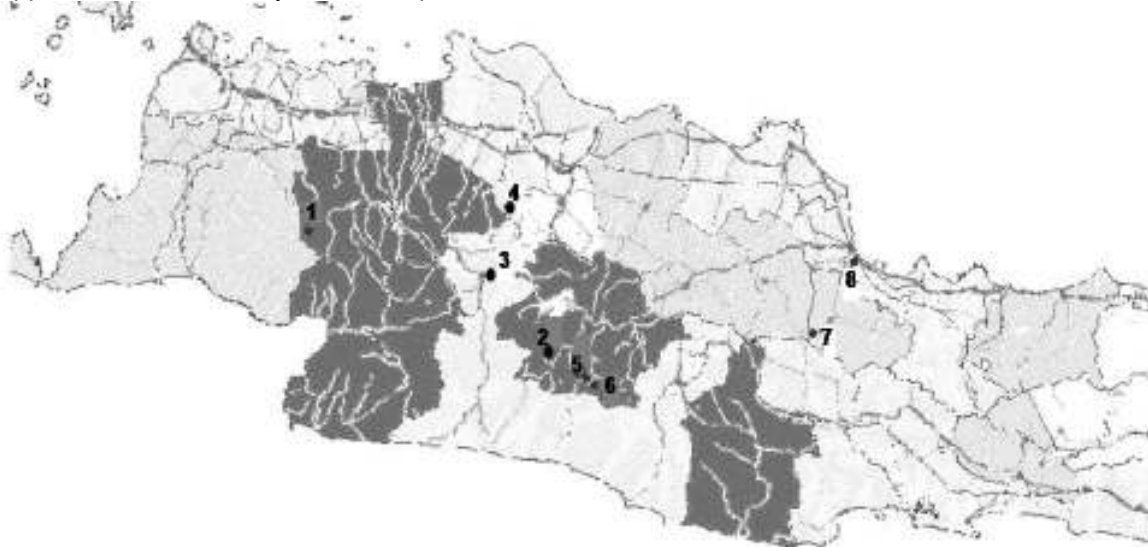
Appendix B: Vulnerability hazard map of West Java and dams location

Dams in the highest hazard area: Pongkor (1), Saguling (2), Gileunca (5) and Cipanunjang (6).
Dams in a high hazard area: Cirata (3), Juanda Jafiluhur (4) and Situpatok (8).
Dam in a medium hazard area: Darna (7).

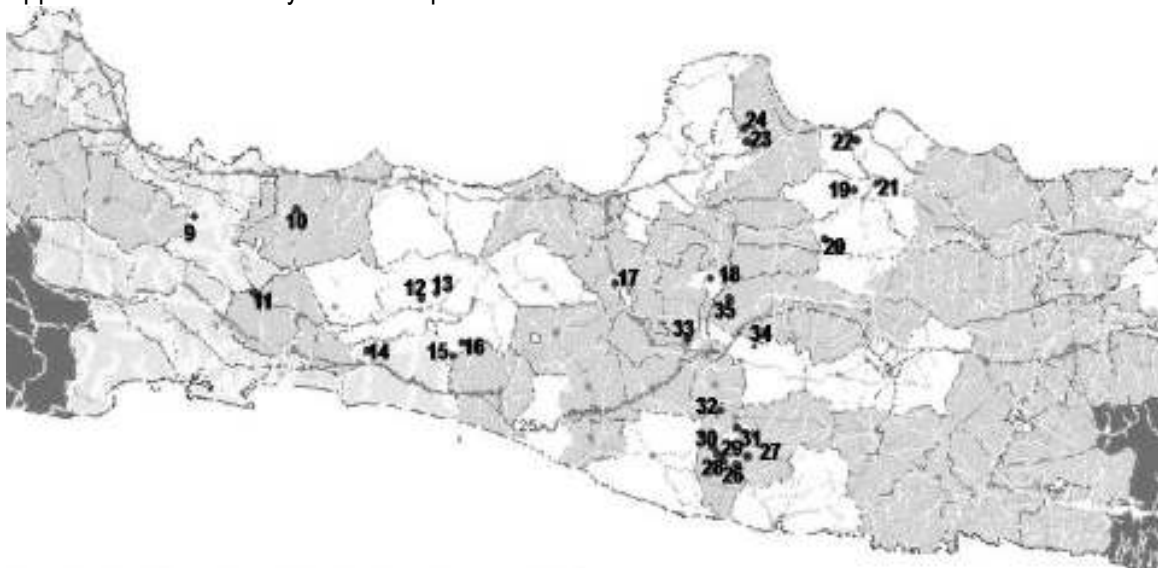
Appendix C: Vulnerability hazard map of Central Java and dams location

Dams in a high hazard area: Malahayu (9) and Sempor (14).
Dams in a medium hazard area: Cacaban (10), Perjalin (11), Klego (17), Kedung Ombo (18), Gunung Rowo (23), Gembong (24), Nawangan (26), Ngancar (27), Song Putri (28), Plumbon (29), Parangjoho (30), Wonogiri (31), Krisak (32), Canglik (33) and Ketro (35).
Dams in a low hazard area: Mrica (12), Garung (13), Wadaslinlang (15), Pejengkolan (16), Greneng (19), Nglangon (20), Tempuran (21), Lodan Wetan (22) and Sermo (25).

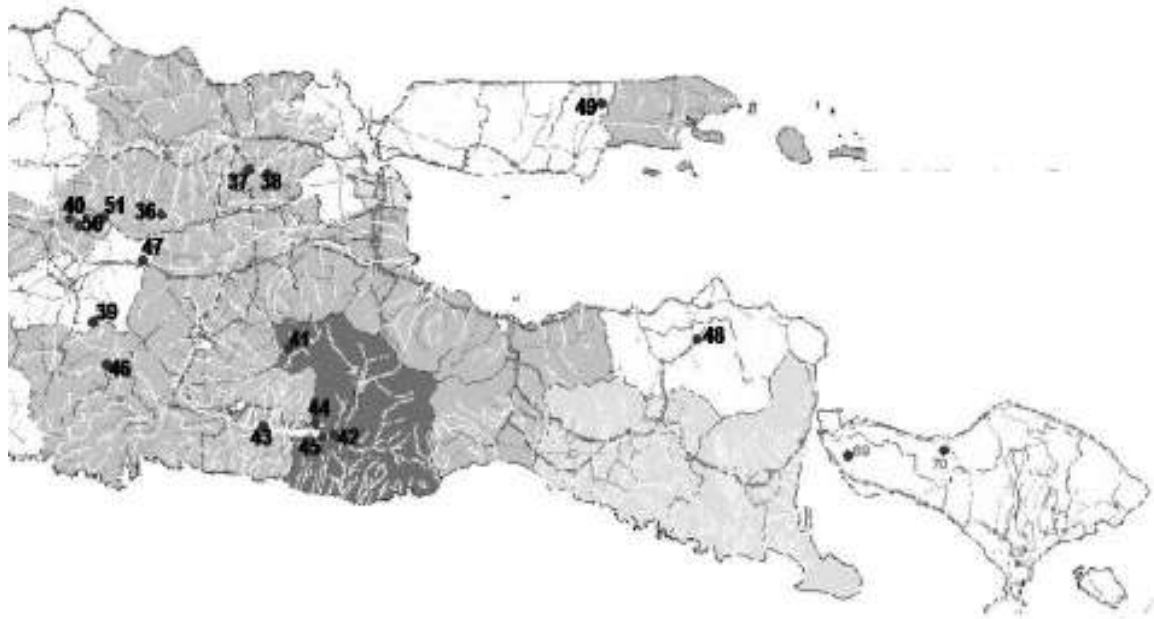
Appendix D: Vulnerability hazard map of East Java and dams location

Dams in the highest hazard area: Selorejo (41), Sengguruh (42), Lahor (44), Sutarni (45).
 Dams in a medium hazard area: Pacal (36), Prijelan (37), Gondang (38), Pondok (40), Wlingi (43), Wonorejo (46), Sangiran (50), Nolopuro (51).
 Dams in a low hazard area: Tlogo Ngebel (39), Bening (47), Sampean Baru (48), Klampis (49).
